Subject: Air brakes, lower blade

Effectivity: Sailplane models LS4 and LS4-a, all serial numbers up to 4340

AD 83-158

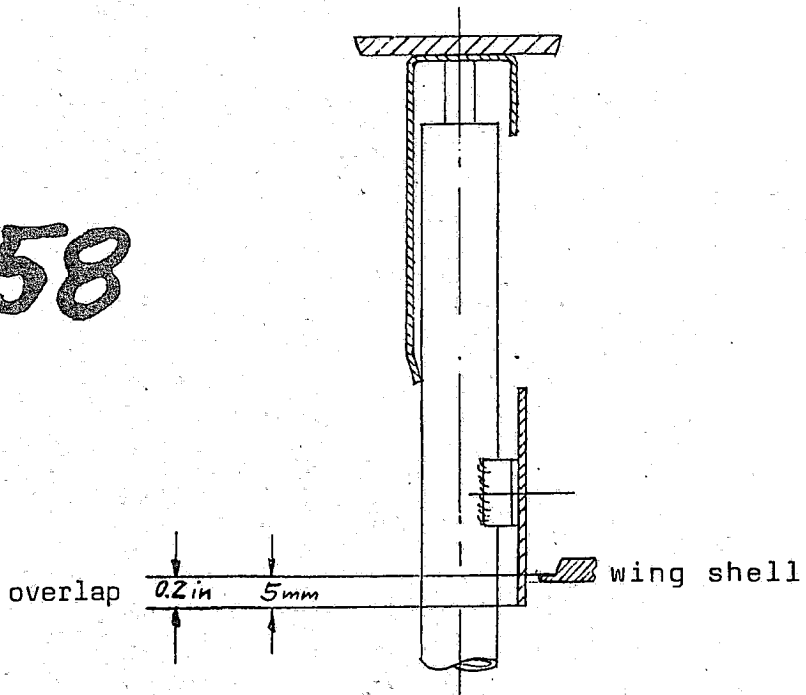
Reason: Possible jamming of lower air brake blade at high speeds

- 1) Assemble sailplane
- 2) With air brakes fully extended, measure overlap between lower blade and wing shell central to levers. When overlap is below 5 mm (0.2 in) proceed according to step 3.
- 3)a. Retract air brakes until overlap is at least 5 mm (0.2 in) at both wings
- b. Check extending height at inner lever, minimum is 150 mm (5.91 in). If below minimum, contact manufacturer.
- c. Rivet stop to air brake pushrod in cockpit from approx. 45° below horizontal such, that main bulkhead reduces travel to yield required overlap

Material: Stop 4R6-15, Steel blind rivet 4x10, (drill dia.4.1 mm, DN 20)
